FINAL
RECORD OF DECISION
Site 36, Aerospace Ground Equipment Yard,
Building 4712
Davis-Monthan Air Force Base, Tucson, AZ

June 2020

PROJECT:
 RECORD OF DECISION
 AT ST-36, AGE YARD BLDG. 4712

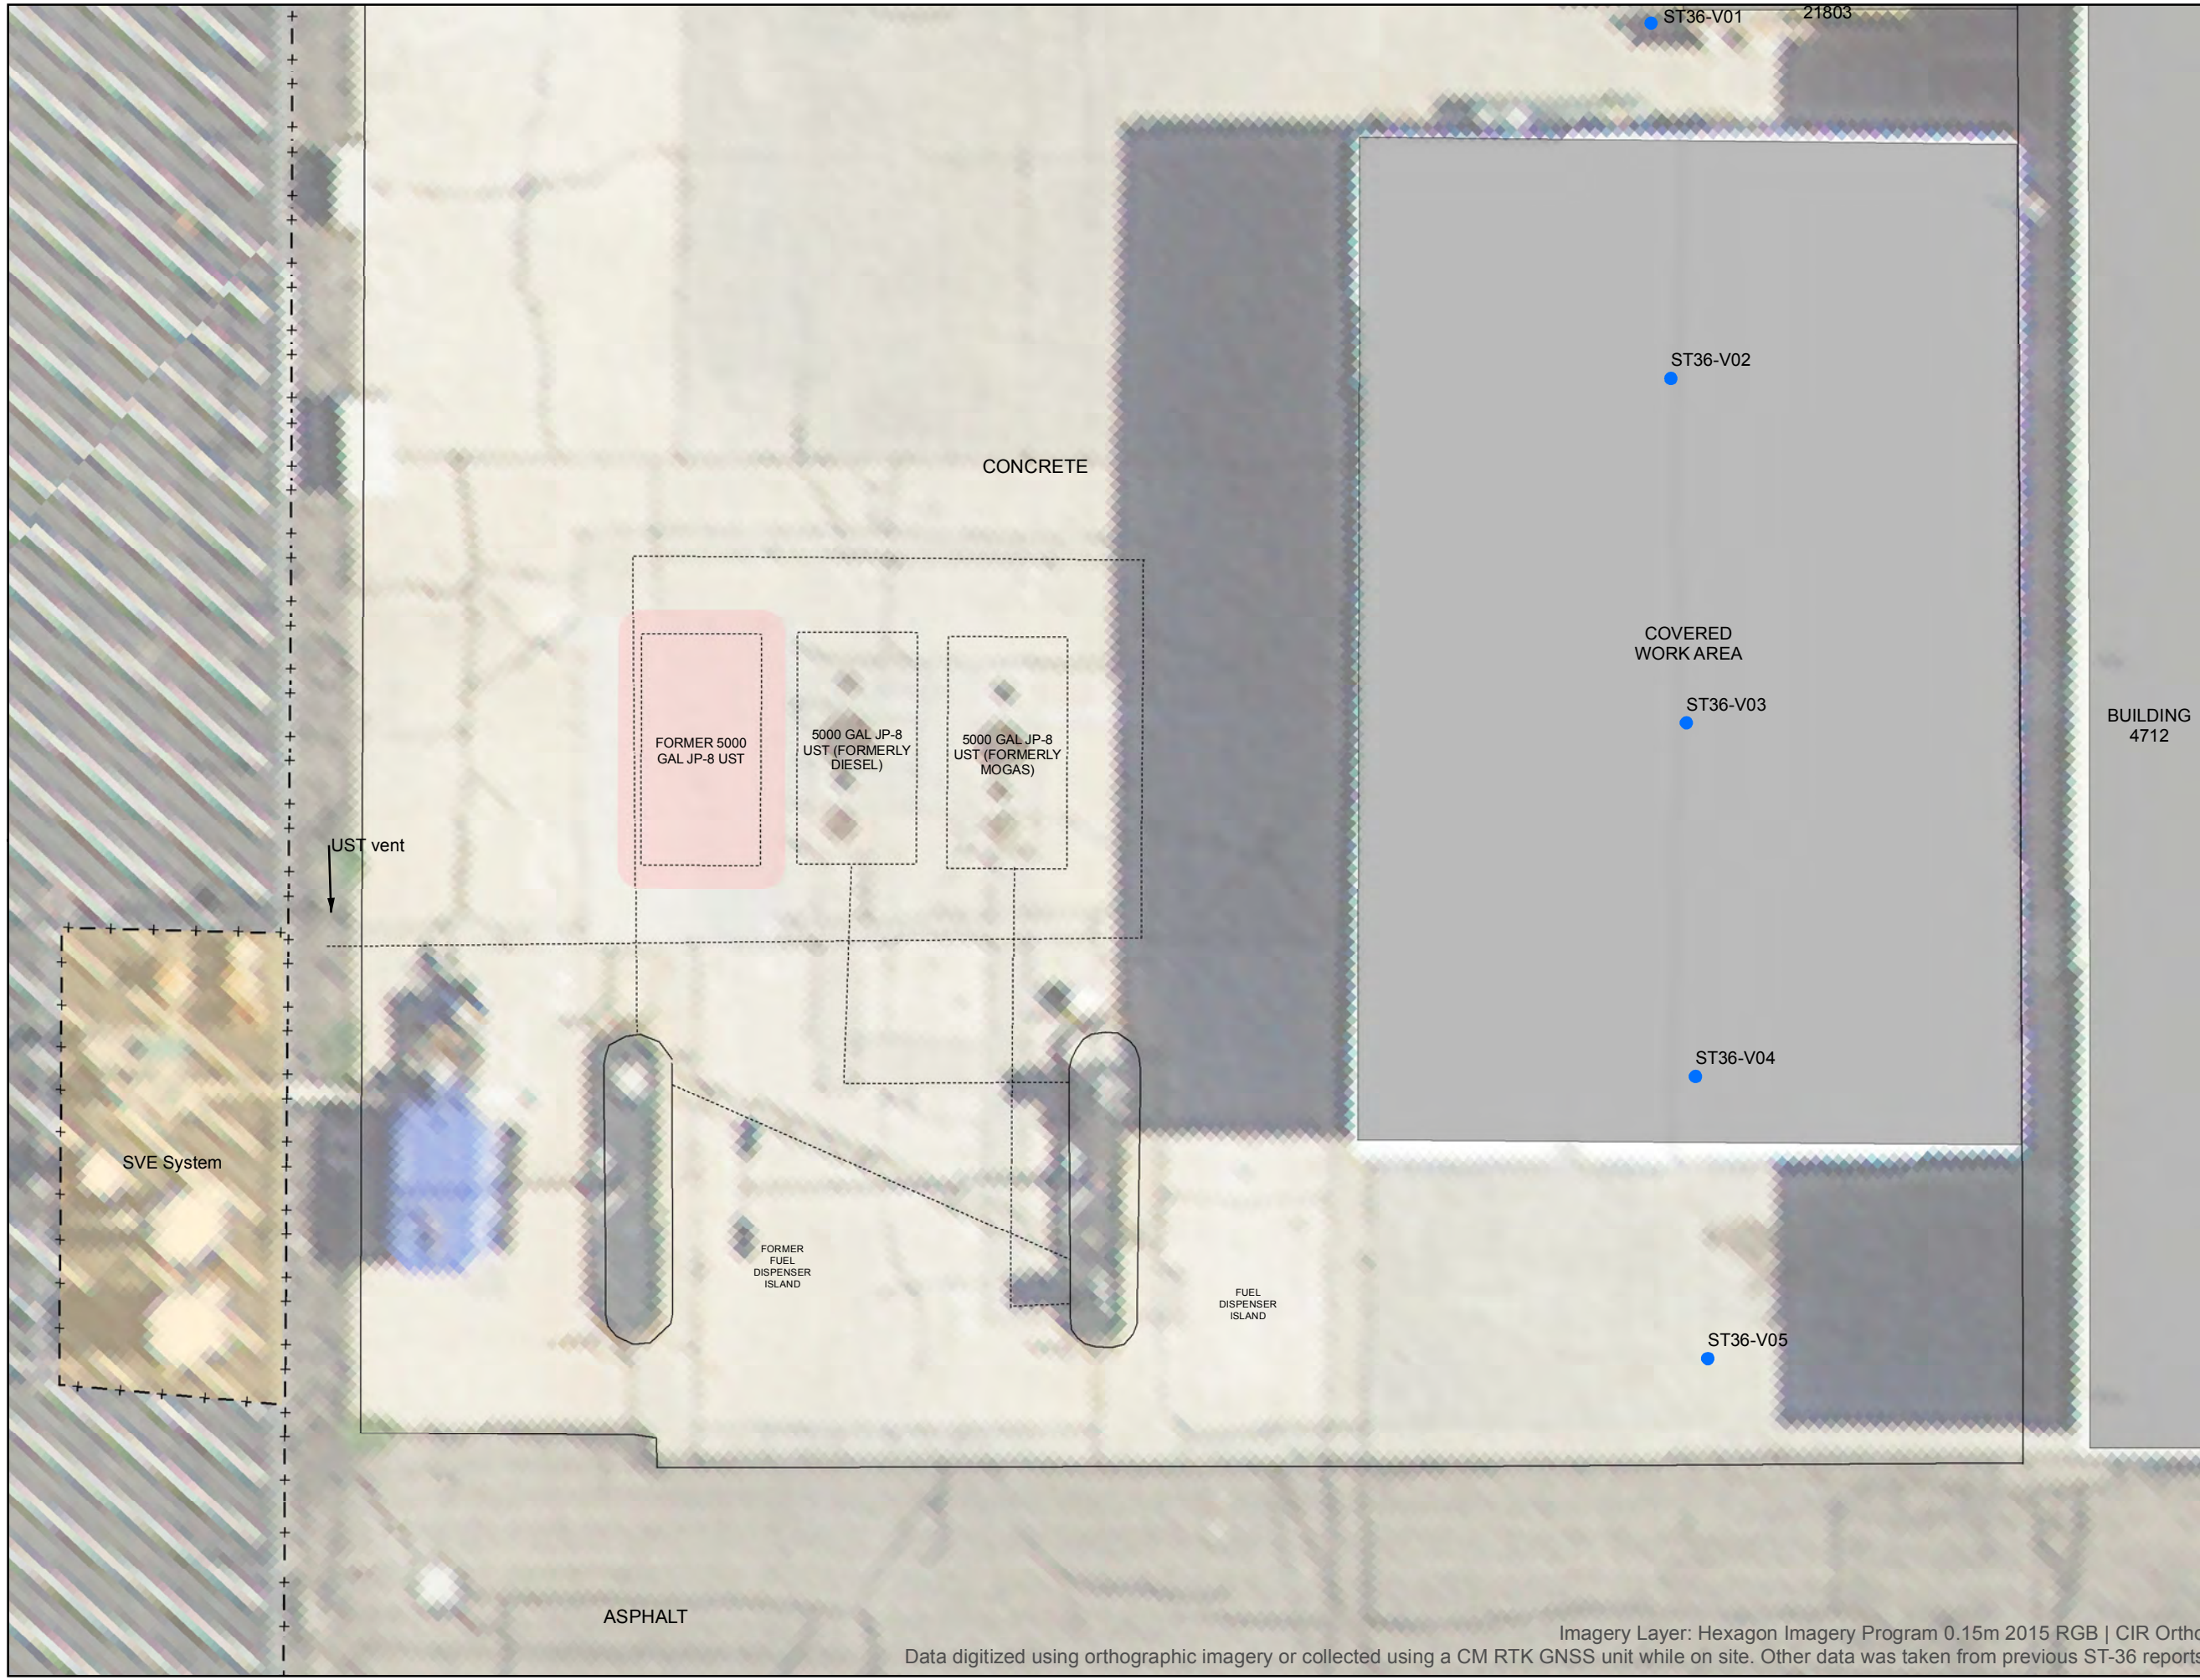
DRN/MOD BY: ADS	DATE: 11/1/2019 REV: N/A	FIGURE: 2-2
--------------------	--------------------------------	-----------------------

TITLE:
 SITE LAYOUT

- LEGEND:
- Sub-Slab Vapor Sample
 - USTs
 - UST Piping
 - Removed UST
 - × Chain-link Fence
 - SVE System Area
 - Buildings

ST-36 comprises approximately one-half acre of DMAFB and is located east of the flight operations area at a fuel dispensing facility utilized by support vehicles. The facility is currently used for maintenance and refueling of AGE. ST-36 is surrounded by a chain link fence adjacent to the intersection of Phoenix Street and Winslow Street. A fueling vehicle maintenance work area and Building 4712 border ST-36 to the southeast. ST-36 formerly housed two above ground fueling dispensers and three USTs. **Figure 2-2** presents a site layout.
